LA-UR-17-31263

Title: Surveillance Report on SAVY-4000 and Hagan Nuclear Material Storage Containers for FY 2017

Issued: 2017-12-22 (rev.1)

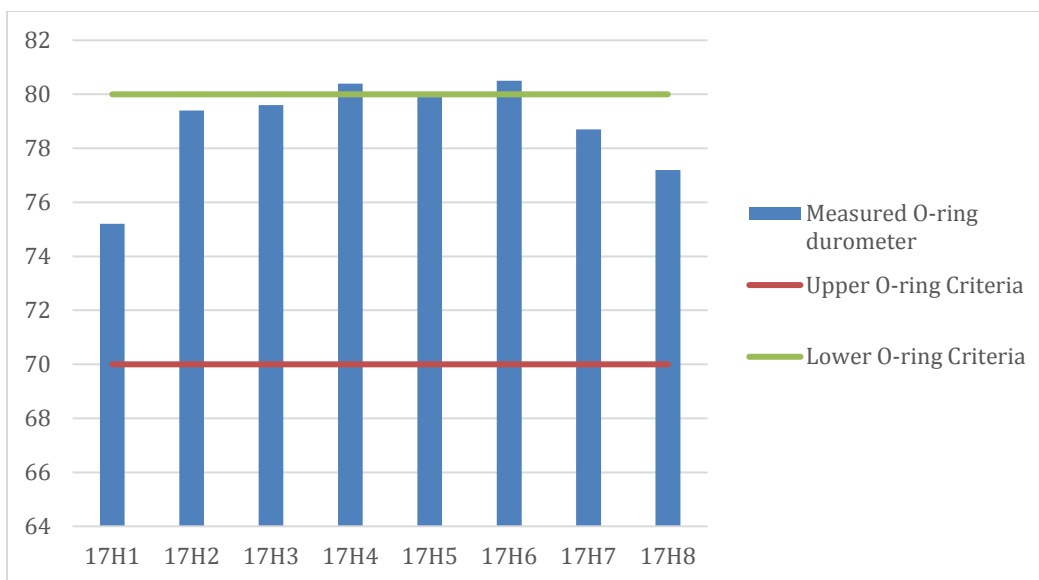
The eight Hagan O-rings tested had hardness between 75.2 and 80.5, with an average of 78.9 durometer units. The measurements are graphed in Figure 4-17, and shown with the passing durometer range represented by the orange and gray bands. Two of the O-rings were slightly above the design specification. The containers are removed for service after testing and they still passed the helium leak test. The population of 20 O-rings used as a baseline in the lifetime extension studies have a hardness of 76.8 ± 6.07 durometer units, with a maximum of 78.6 and a minimum of 73.9 durometer units. These baseline O-ring measurements were performed on unused Hagan O-rings that had been stored in plastic bags.

Figure 4-17. Durometer measurements, shown with an green or red line representing the criteria bounds for the hardness of O-rings.

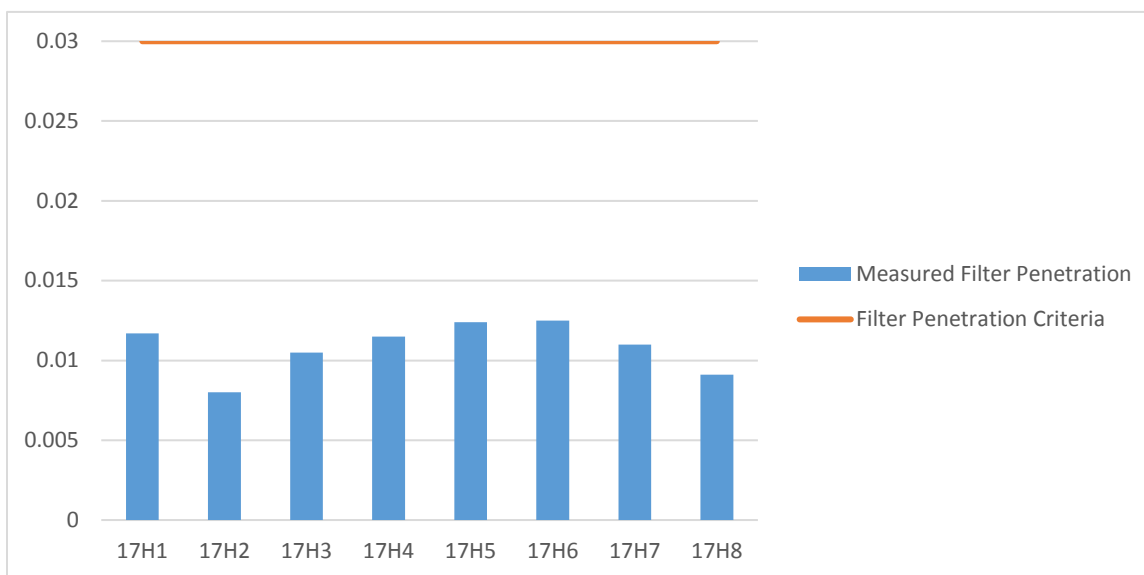
The aerosol data are reported as a percent penetration, also known as the percent leakage. The set of particle penetration measurements shown in Figure 4-18 is narrowly distributed and is at least a factor of 2 lower than the requirement.

Figure 4-18. Filter particle penetration measurements. Values on y-axis are the filter efficiency.

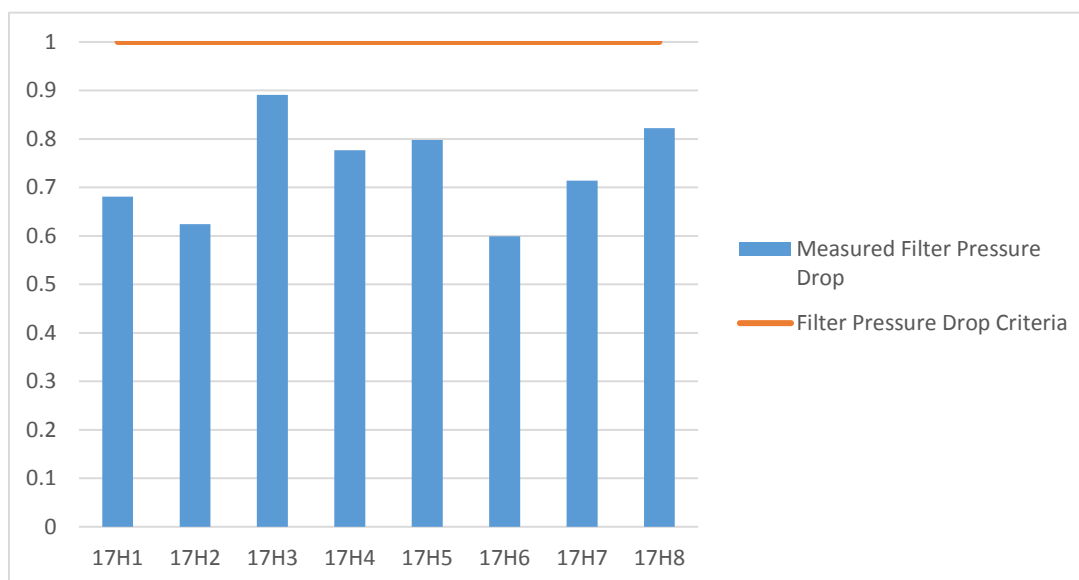
The pressure drop measurements have an average of 0.738 in. W.C. A graph of the measurements is shown in Figure 4-19. No filters failed the pressure drop criteria.

Figure 4-19. Filter pressure drop measurements. Values on y-axis are in inches W.C.

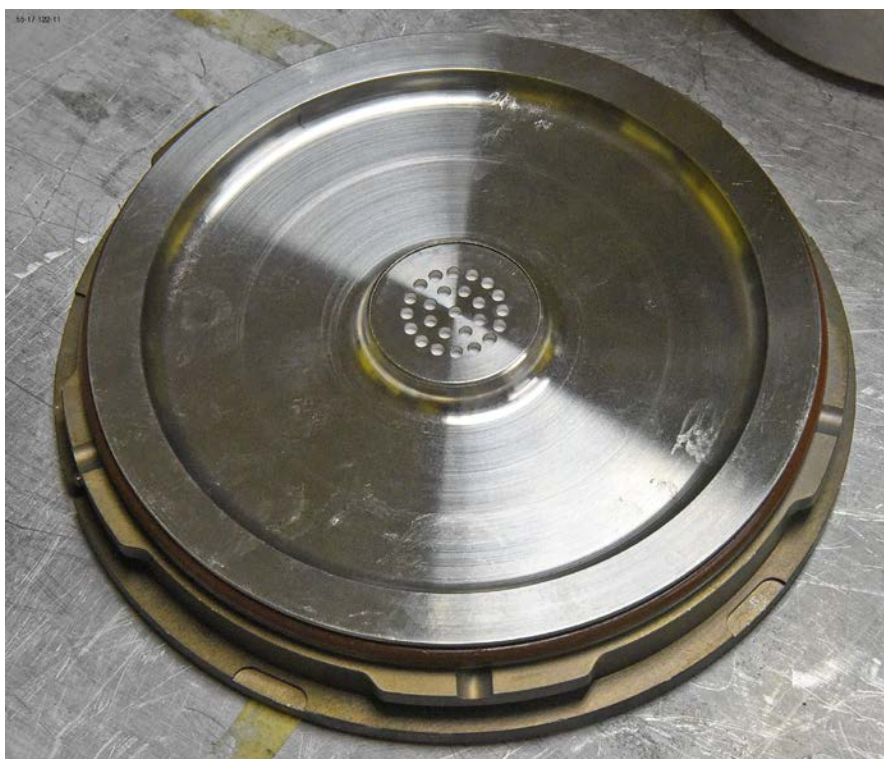
Minor corrosion found on the interior walls of the container. The thumb latch was also found to be sticky on this container. The suspected corrosion was wiped and the residue was brown in color. The underside of the lid did not have much marking, Figure 4-22, compared with the container body seen in Figure 4-23. The container was found with corrosion markings, Figure 4-23 and the markings did not change significantly after wiping with an isopropyl alcohol wipe as seen in Figure 4-24 . This container is capped and placed inside another SAVY-4000 container.

Figure 4-22. Underside of lid of container 17S3 with no significant markings

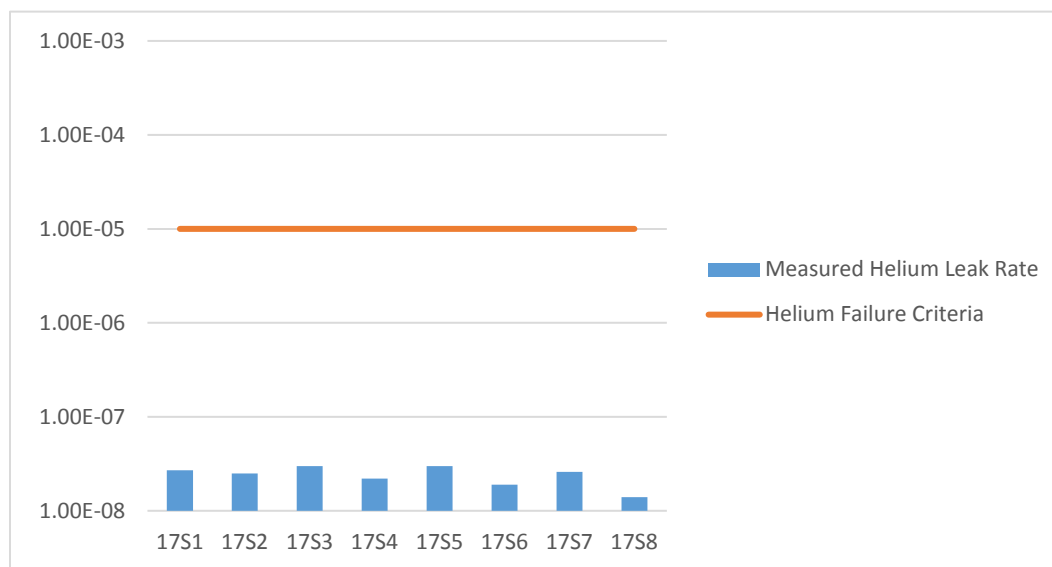
The leak rate results for storage and transfer containers with O-rings installed are shown in Figure 4-30. For storage containers, the measured leak rate ranged between 1.4×10^{-8} and 3.0×10^{-8} atm cc/s of helium at 75 torr into vacuum. For transfer containers, the leak rate ranged between 2.0×10^{-9} and 7.5×10^{-7} atm cc/s. Every container passed the leak test, with all measurements being below the failure criterion of 1×10^{-5} atm cc/s.

Figure 4-30. Leak rates for surveillance containers, measured for each container are shown as blue bars with the failure criteria shown with the orange line.

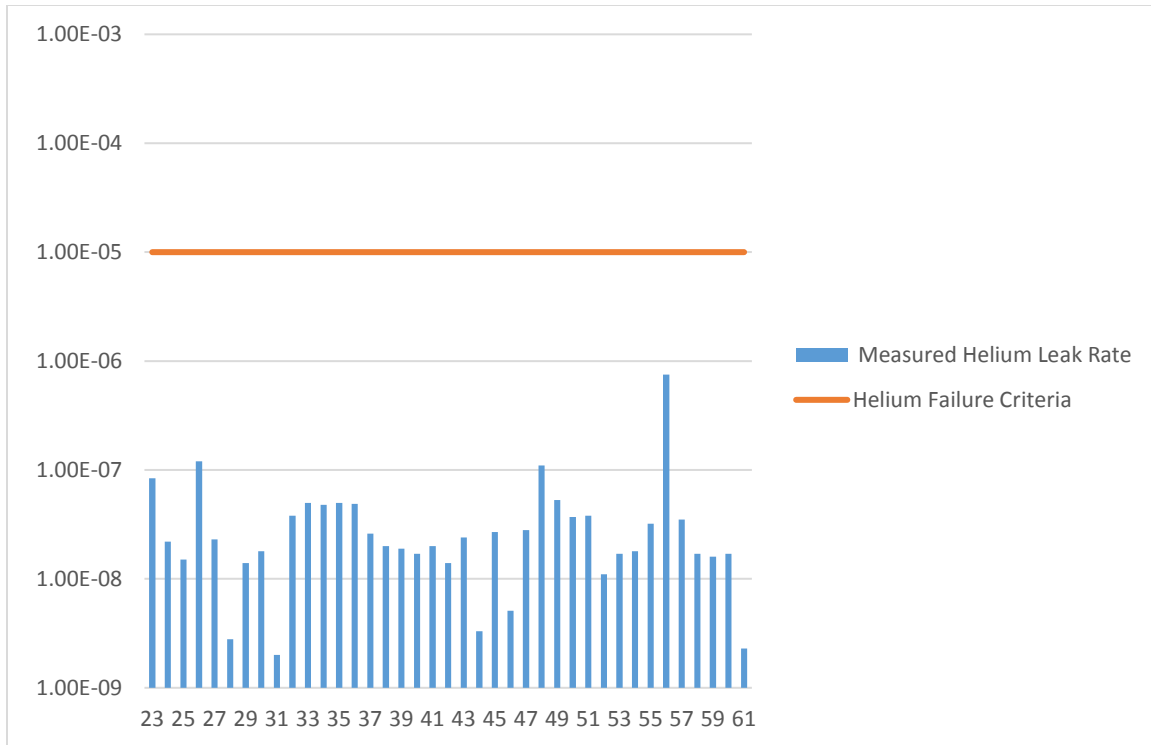
Figure 4-31. Leak rates for transfer containers, measured for each container are shown as blue bars with the failure criteria shown with the orange line.

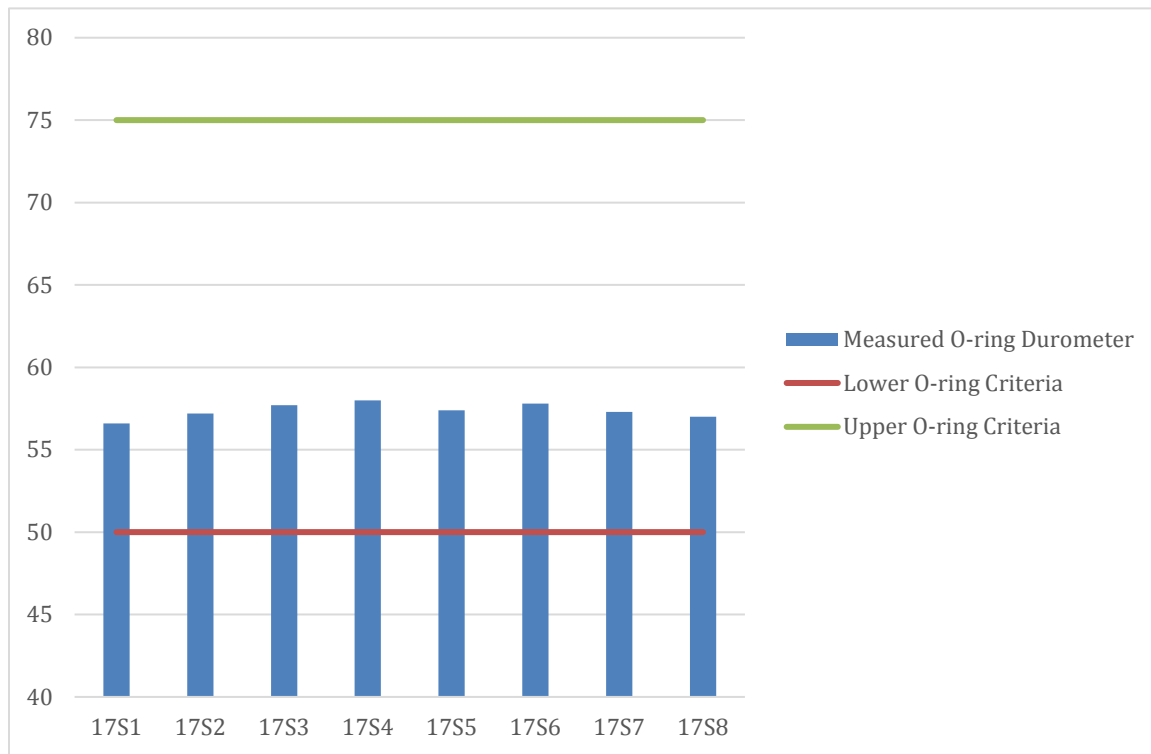
The 8 surveillance O-rings were found to have hardness of between 56.6 and 58, with an average of 57.4 durometer units. The 39 transfer container O-rings had a hardness between 53.6 and 60.5, with an average of 57.4 durometer units. The 28 O-rings used as a baseline in the lifetime extension studies have a hardness of 57.5 ± 2.62 durometer units, so the storage and transfer O-rings are similar in hardness to unused O-rings. The 2.62 unit error is the reproducibility standard deviation as given in ASTM D2240. The measurements are graphed in Figure 4-32. None of the O-rings are especially hard or soft

Figure 4-32 Durometer measurements of the surveillance SAVY-4000 O-ring with the red and green bands showing the upper and lower failure limits.

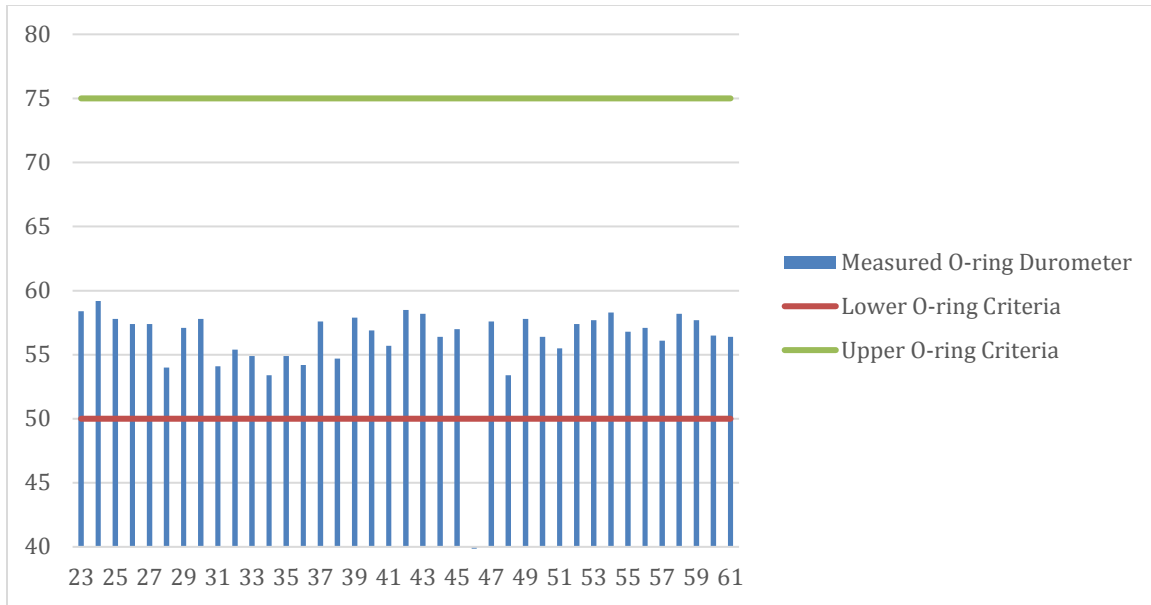
Figure 4-33. Durometer measurements of the transfer container SAVY-4000 O-ring with the green and red bands showing the upper and lower failure limits.

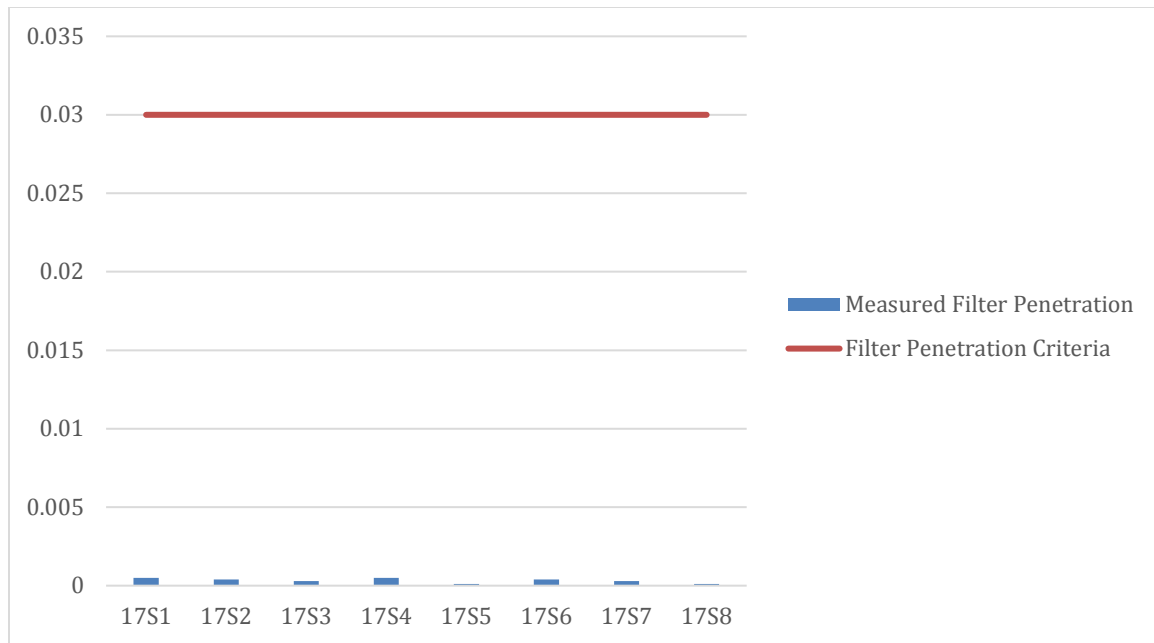
The aerosol data are reported as a percent penetration, also known as the percent leakage. The set of particle penetration measurements is narrowly distributed and very far from the failure criterion as graphed in Figure 4-34 for storage containers and Figure 4-35 for transfer containers. A set of baseline particle penetration measurements does exist, but it is not clear how those measurements, taken on a different type of instrument with a different configuration, relate to the measurements taken in PF-4 with our instrument. Although we may not be able to tell how the particle penetration is changing from baseline, we will be able to track how the particle penetration changes relative to containers' peers in the sample population.

Figure 4-34. Filter particle penetration measurements for storage containers.

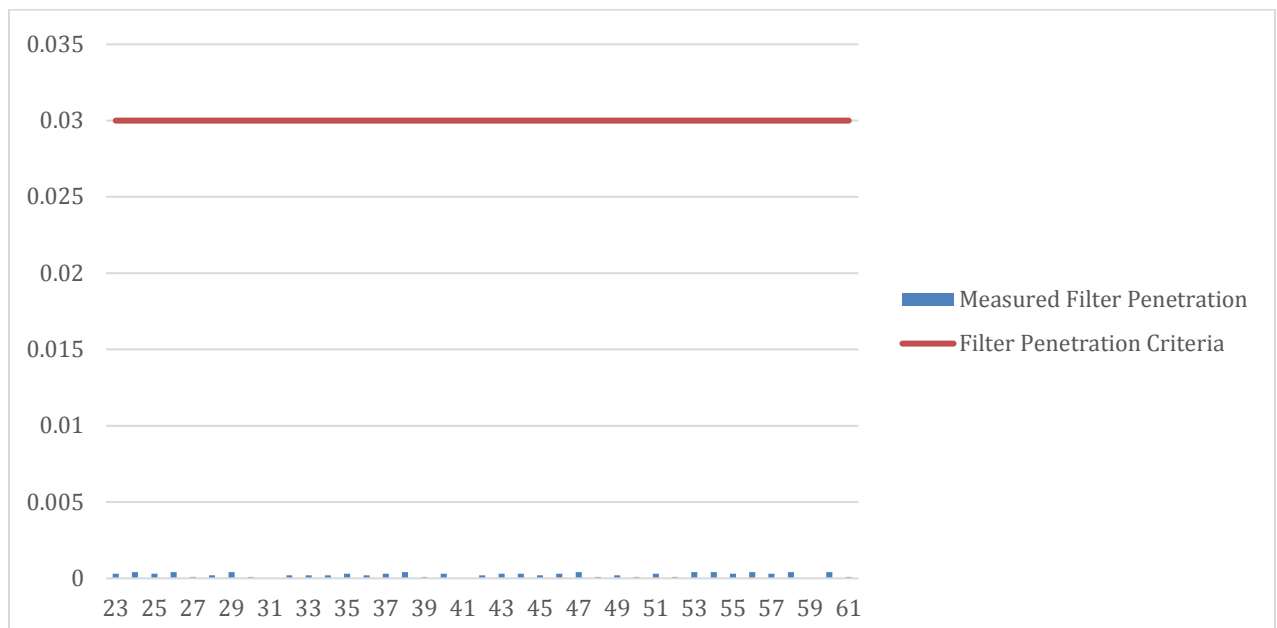
Figure 4-35. Filter particle penetration measurements for transfer containers.

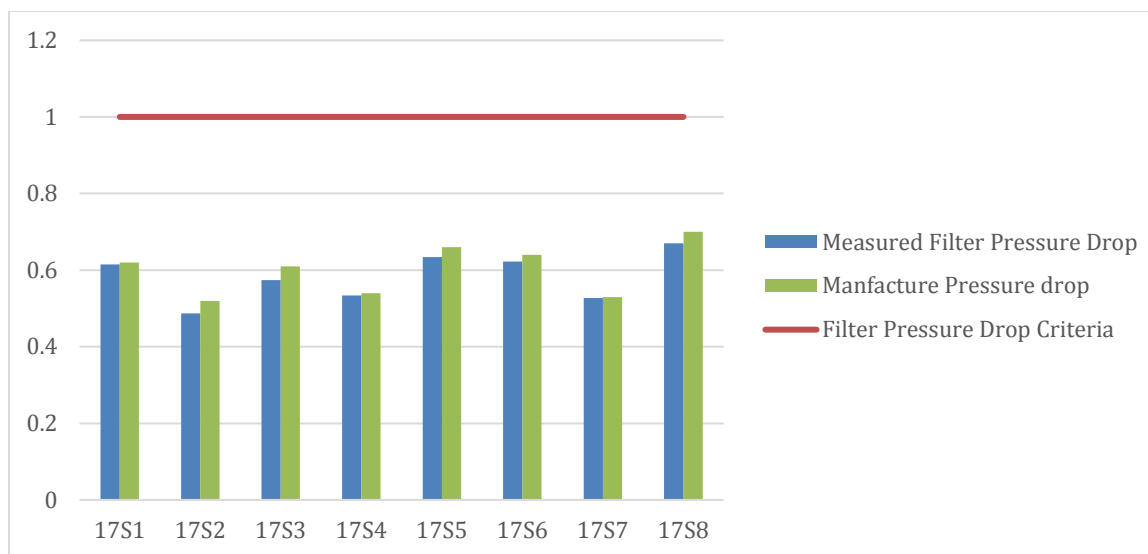
The pressure drop measurements have an average of 0.58 in. W.C. ± 0.09 for storage and 0.64 in. W.C. ± 0.09 for transfer containers. The results are graphed below in Figure 4-36 and a graph of the measurements is shown in Figure 4-36.

Figure 4-36. Filter pressure drop measurements for storage containers.

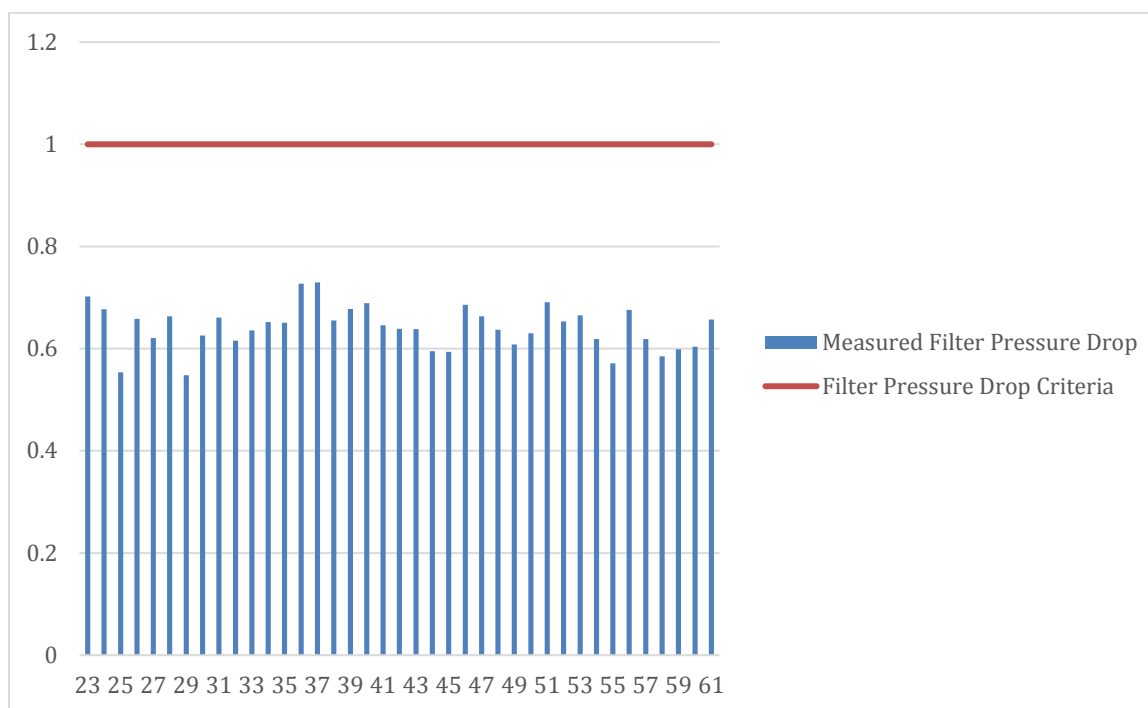
Figure 4-37. Filter pressure drop measurements for transfer containers.

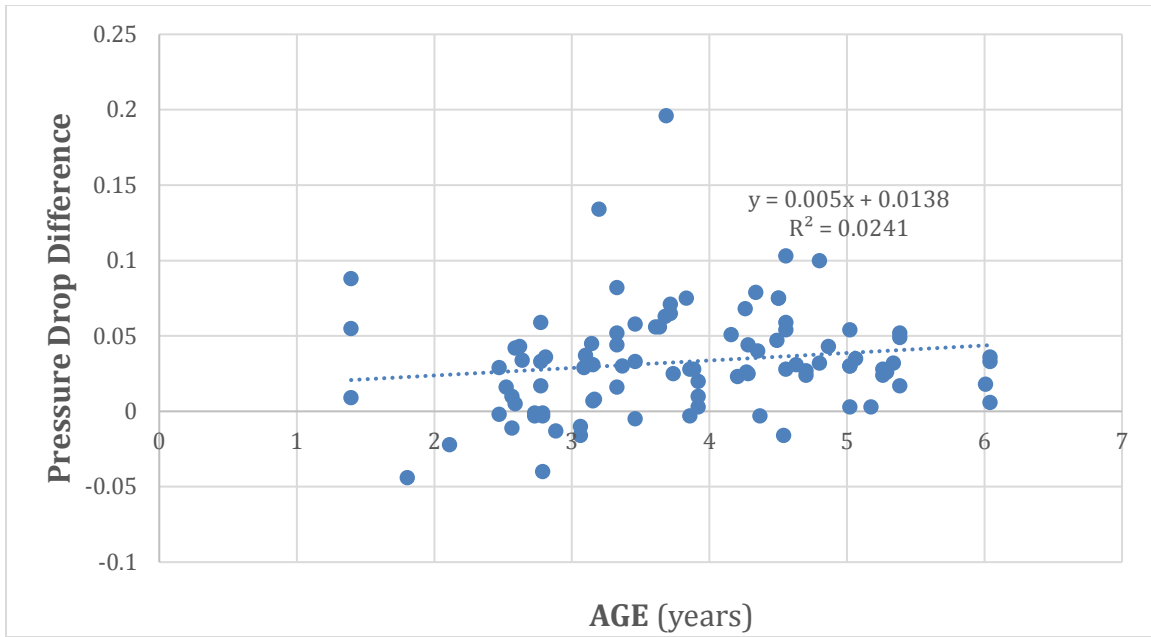
The pressure drop measurement does not have a significant correlation with total dose or item thermal power or with container age. Figure 4-38 shows the pressure drop change from manufacture to the tested pressure drop versus the container age. There does not appear to be a significant correlation of pressure drop change compared with the age of the container.

Figure 4-38. Pressure drop difference versus container age.

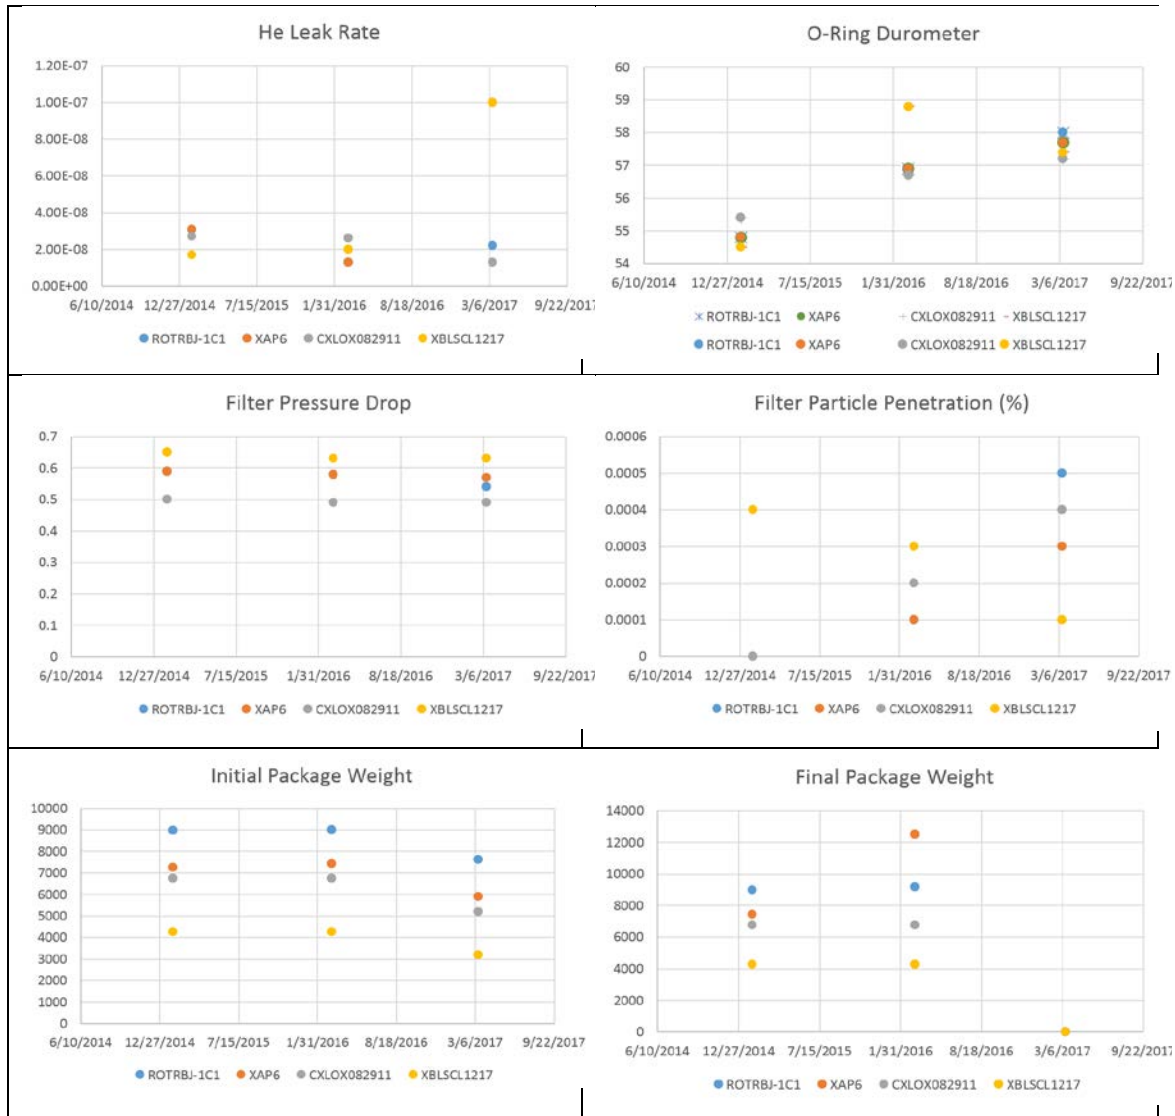
Figure 4-39 contains graphs for each surveillance measurement as a function of the storage time. The graphs contain each of the 4 NDE-only items surveilled for the past 3 years. The only measurement that may show a trend over time is the O-ring durometer measurement. The O-rings appear to be getting slightly harder. Continued durometer measurements are recommended. The pressure drop and particle penetration values are also unchanged from the previous years. Over all, there is no evidence of change in the O-rings' ability to maintain a seal during their year in storage.

Figure 4-39. NDE-only annual surveillance data as a function of time
